Legend for 57' Custom Safari 2 Door Seat, Cargo and Tailgate Interior Trim Pieces

Cargo Area Trim for Safaris ~ By Michael Munger

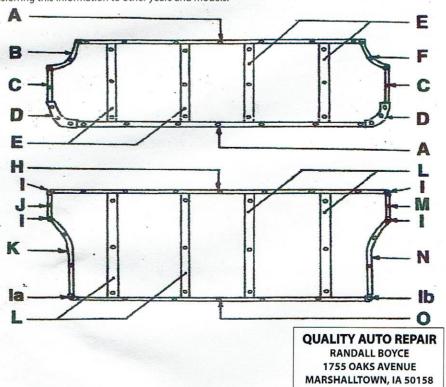
Legend for '57 Custom Safari 2 Door Seat, Cargo and Tailgate Interior Trim Pieces.

- Seat Edge Trim (3/4x1/2)
- Cargo Edge Trim (5/8x1/2)
- Tailgate Edge Trim (1/2x1/8)

Special Pieces:

Code Letter:	Description:	
D	Hinge Cover	
1	Corner Cover	
la	Special Corner Piece	
lb	Special Corner Piece

Cour Letter	Length in Inches	" Holes	
P X	A	43 5/8	7	
	B C	CURVED	3	
	C	5 7/8	1	
	F	CURVED	3	
	P	46	8	
/\ \ \ \ \ \ \ \ \ \ \ \ \ \	S T	20 5/8	1	
	T	21	1	
	V	9 1/8	2	
$Q \rightarrow \cdot \cdot \cdot \cdot \cdot \cdot \cdot \cdot \cdot $	Z	34 7/8	5	
	AA	34	5	
R	DD	33 3/4	5	
	EE	42 1/4	7	
S AA	FF	15	3	
T BB	GG	20 3/8	5	
	II	20 3/8	5	
			2	
U	E	13	3	
V W EEDI	L	17 1/2	3	
** #	R	45 1/2	6	
	W	19 1/4	3	
	X	24 3/4	4	
FF - I O O O O O O	HH	15	3	
	Q	41 1/8	5	
	U	6 1/2	1	
cc // / /	Y	25 7/8	3	
GG /	BB	15 1/8	3	
HH—/	CC	6 5/8	1
